Hose Connector Type ECOVOS

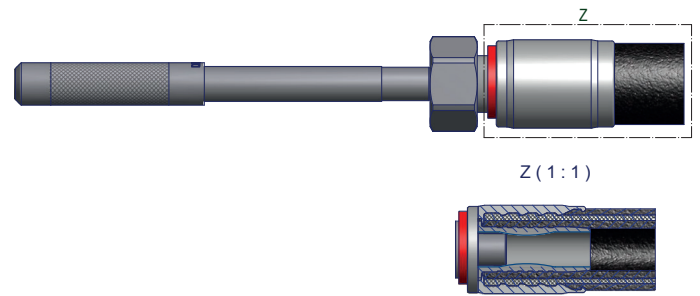
Fig. 1: Excessive crimping, maximum reduction of nipple diameter exceeded

The inside nipple diameter is reduced excessively in the sealing zone through the crimp dimension, which is too tight. ATTENTION: This crimped connector is not functional. This error might result in premature failure of the hose line. The crimp diameter must be increased by several tenths of a millimeter!

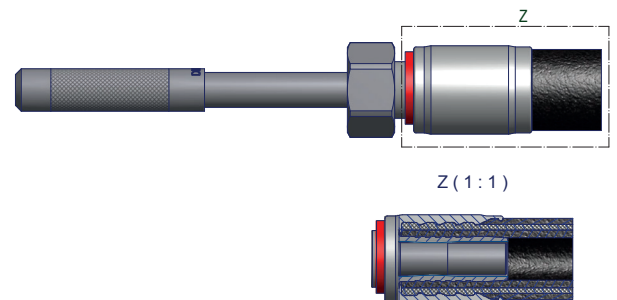
Fig. 2: Maximum reduction of nipple diameter reached

This illustration shows the maximum permissible reduction of the inside nipple diameter. The crimp diameter should not be reduced any further, since otherwise there might be the risk of a premature failure of the hose line!

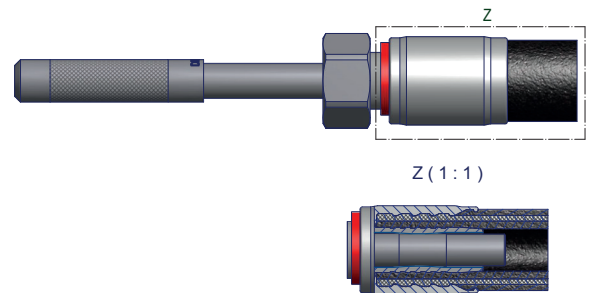
Fig. 3: Ideal reduction of nipple diameter

The perfect reduction of the nipple diameter has been reached. The crimp diameter should not be changed any more. It must, however, be checked prior to any change of the hose batch. The reached crimp dimension will correspond to the standard crimp dimension as determined from the press dimension table.

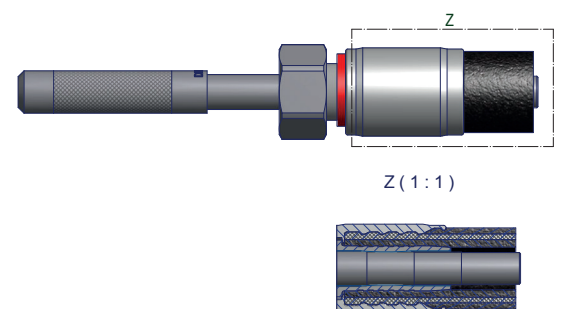
Fig. 4: Minimum reduction of nipple diameter

This illustration shows the minimum permissible reduction of the inside nipple diameter. In this case, it is still possible to reduce the crimping diameter by a few tenths of a millimeter!

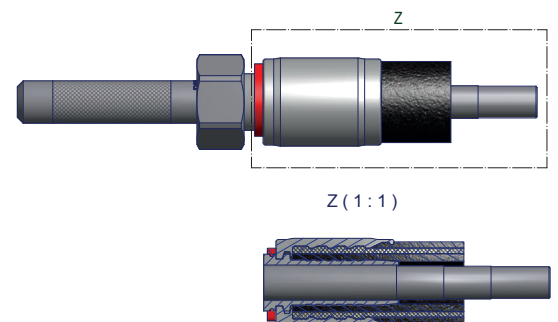
Fig. 5: No reduction of nipple diameter

Crimping did not cause any reduction of the inside nipple diameter. The crimping diameter is too large. ATTENTION: This crimped connector is not functional. There is a risk of a leak or of the hose slipping off the crimped connector. It is necessary to decrease the crimping diameter by several tenths of a millimeter!
