Hose Connector Type MULTIVOS

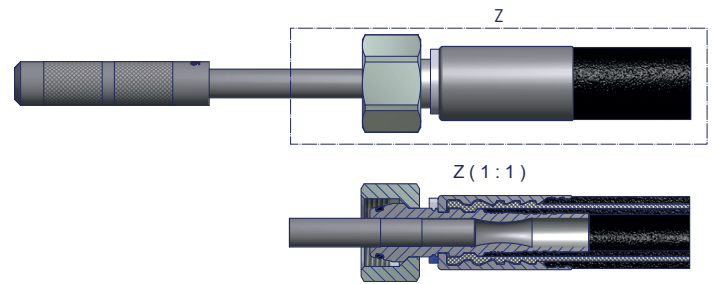
Fig. 1: Excessive crimping, maximum reduction of nipple diameter exceeded

The inside nipple diameter is reduced excessively in the sealing zone through the crimp dimension, which is too tight. ATTENTION: This crimped connector is not functional. This error might result in premature failure of the hose line. The crimp diameter must be increased by several tenths of a millimeter!

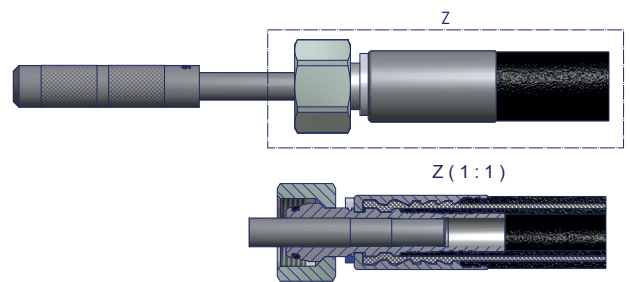
Fig. 2: Maximum reduction of nipple diameter reached

This illustration shows the maximum permissible reduction of the inside nipple diameter. The crimp diameter should not be reduced any further, since otherwise there might be the risk of a premature failure of the hose line!

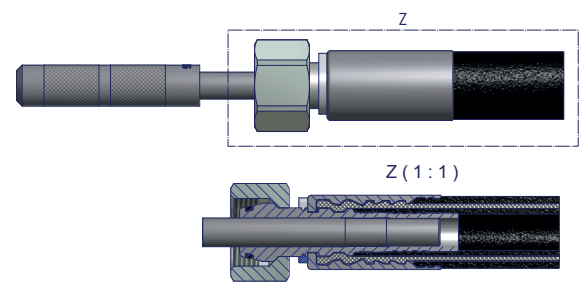
Fig. 4: Minimum reduction of nipple diameter

This illustration shows the minimum permissible reduction of the inside nipple diameter. In this case, it is still possible to reduce the crimping diameter by a few tenths of a millimeter!

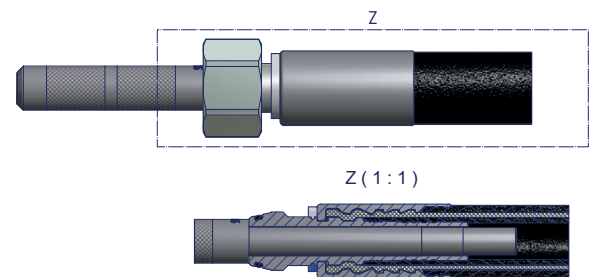
Fig. 5: No reduction of nipple diameter

Crimping did not cause any reduction of the inside nipple diameter. The crimping diameter is too large. ATTENTION: This crimped connector is not functional. There is a risk of a leak or of the hose slipping off the crimped connector. It is necessary to decrease the crimping diameter by several tenths of a millimeter!
